**GENERAL PHILIP SCHUYLER HOUSE**  
**HISTORIC STRUCTURE REPORT**

**Saratoga National Historical Park  
Schuylerville, New York**

**Volume 1 of 2**

**2003**

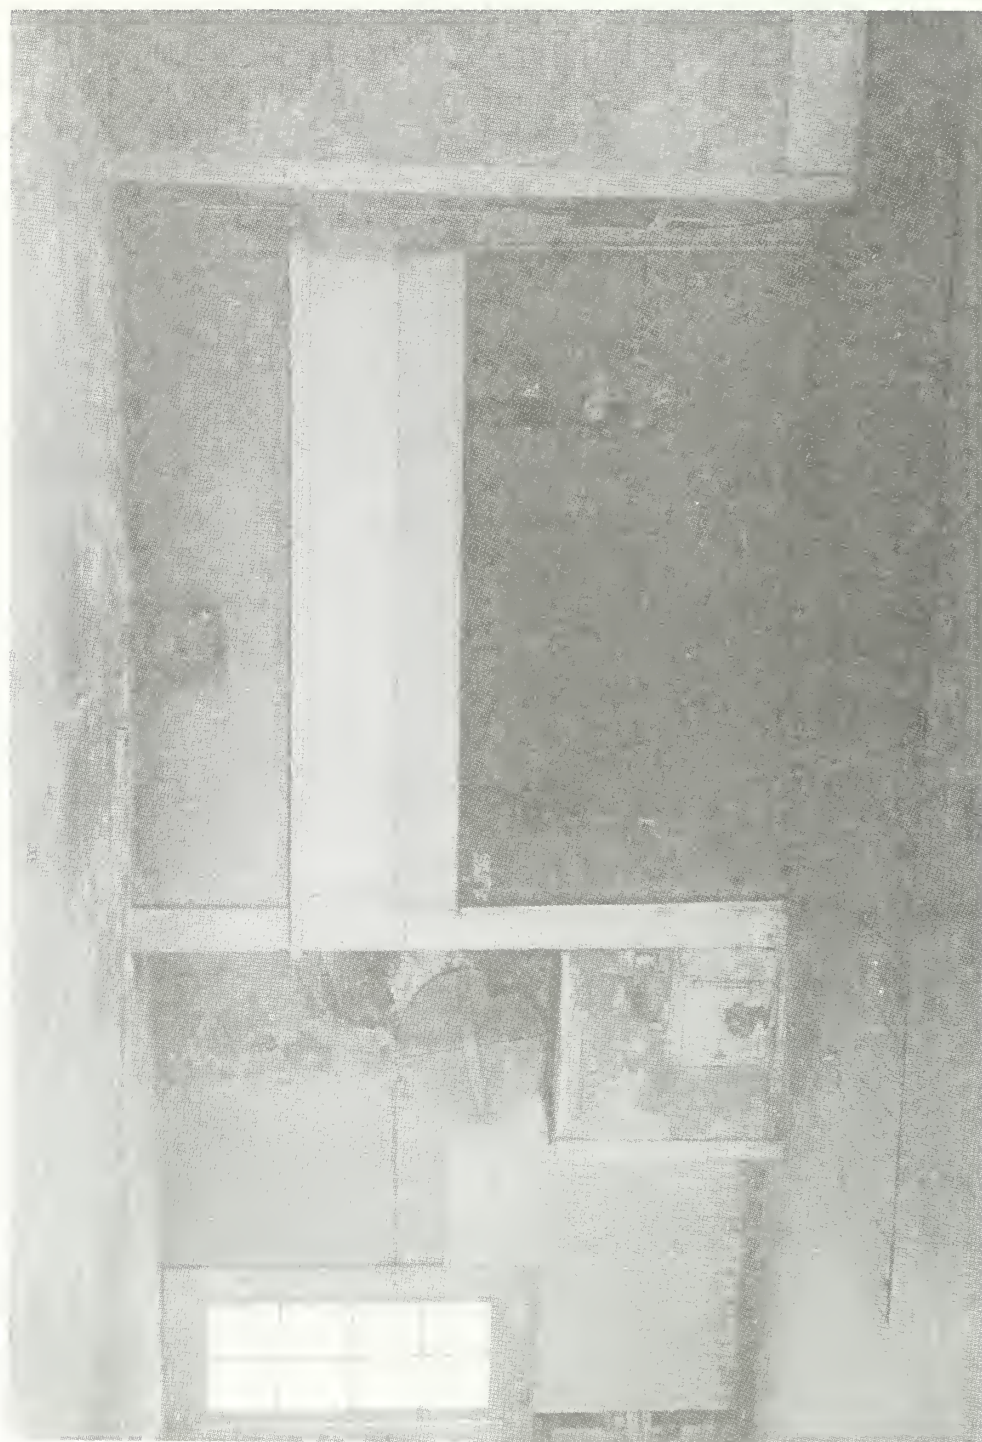
**Figure 31.** Schuyler House: Kitchen wing, east wall of kitchen (Room 105) before restoration (ca. 1955).

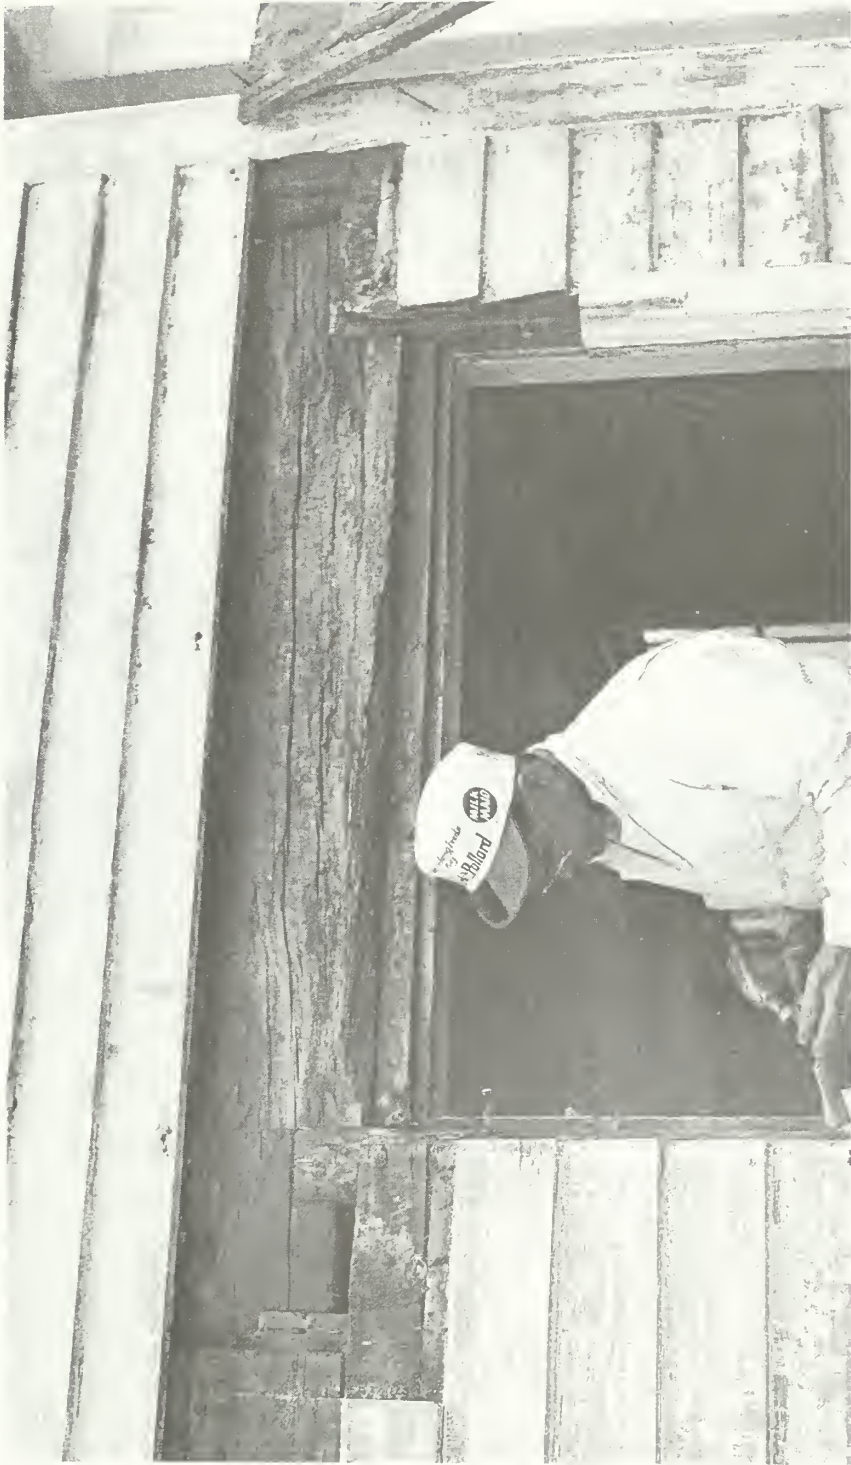
Figure 38. Schuyler House: Northwest corner, window W112 repairs (ca. 1955).

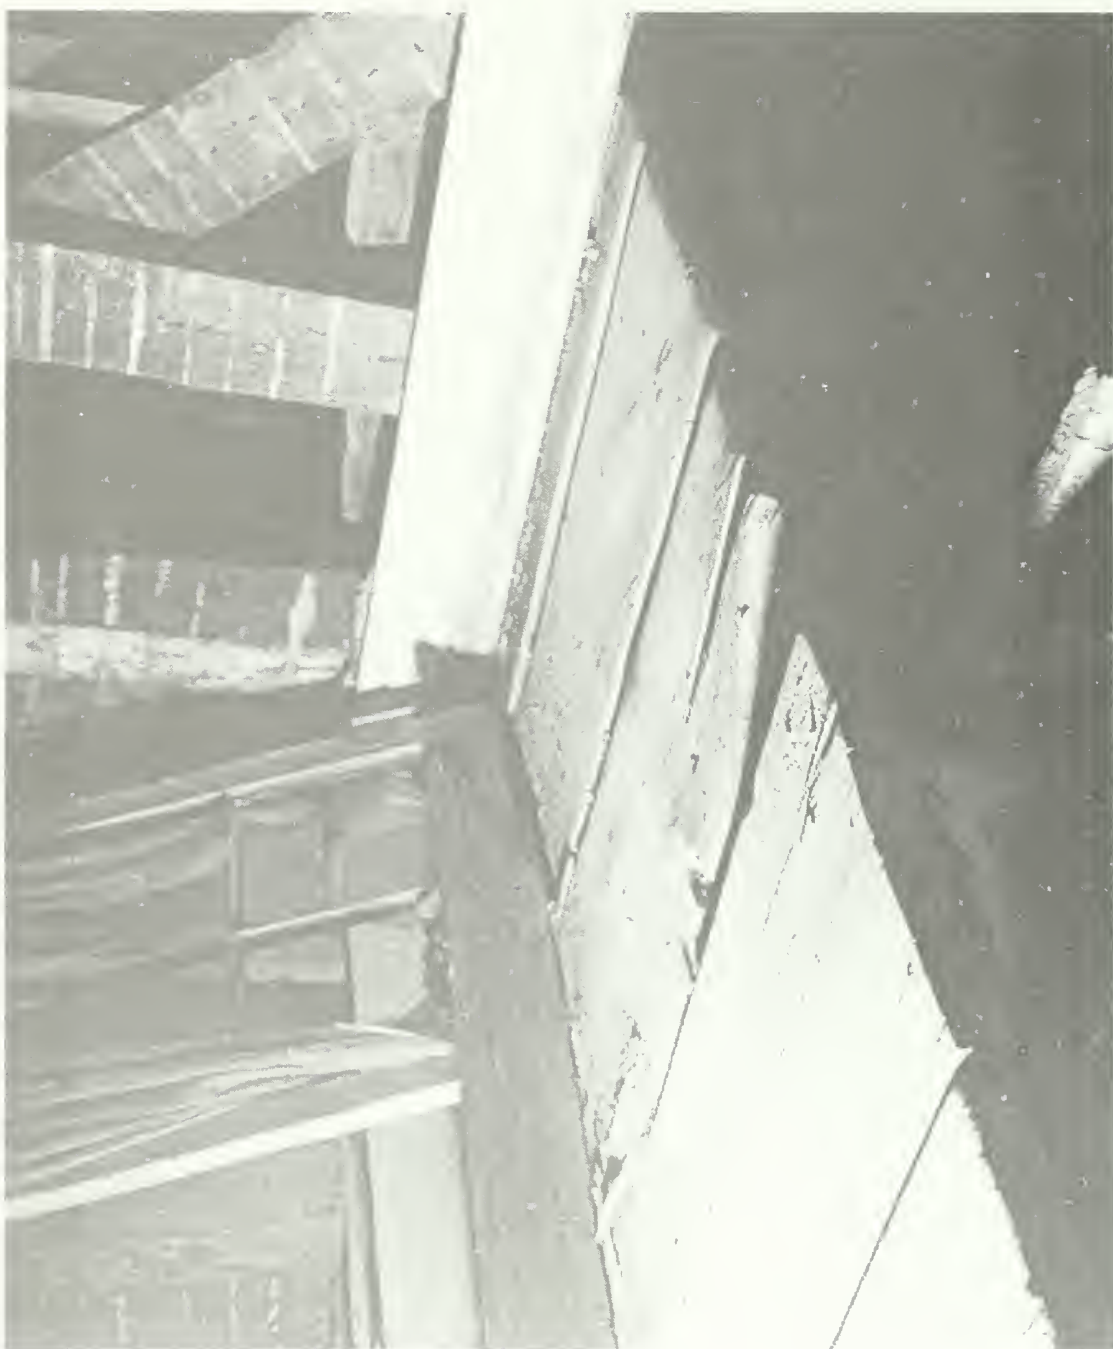
**Figure 61.** Schuyler House: Second story of kitchen wing after ca.-1815 lath and plaster removed; worn flooring in hall (Room 206) at location of ca.-1780 staircase landing (1958).
